Topic: Aesthetic dentistry

Meenakshi Lall presents a case report detailing the management of severe fluorosis by combined minimal invasive aesthetic procedure

Management of stained fluorotic teeth

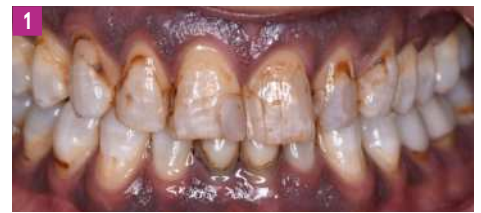
FIGURE 1: Initial situation. According to the TF index score, the maxillary and mandibular teeth were classed as 'severe'

Intraoral examination revealed brownish discolouration of enamel with all maxillary and mandibular incisors, canines and premolars. The pattern of discolouration was bilateral and symmetrical. The surfaces of some of these teeth were pitted.

Discolouration was more prominent on maxillary teeth compared to mandibular teeth (Figure 1).

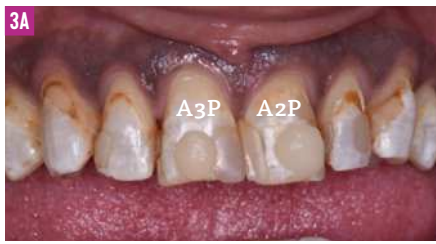
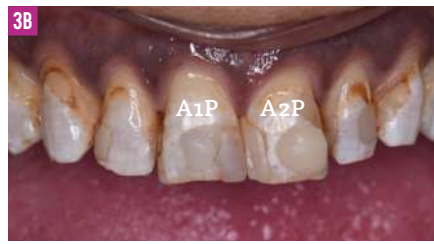
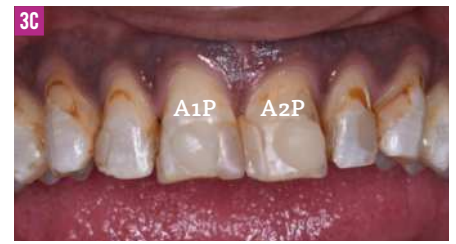
FIGURES 3A, 3B and 3C: Shade taking Venus Pearl and Diamond composite

I used Venus Pearl composite A1 shade in interproximal, buccal and incisal areas and A2 shade in cervical areas, since it was the nearest match and has good aesthetic quality (Figure 3).

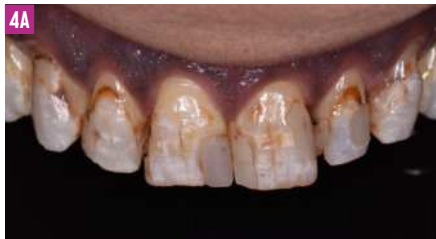
FIGURE 4A: White opaque areas, brown discoloration with surface porosities on enamel

Figure 4a shows the pre-treatment presentation with white opaque areas, and brown discolouration with surface porosities on the enamel.

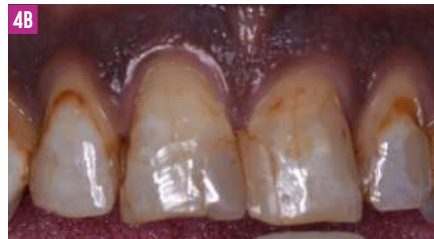
FIGURE 4B: Two-week home-based bleaching with 10% carbamide peroxide for six to eight hours at night

Two-week home-based bleaching with 10% carbamide peroxide (Boutique) was carried out for six to eight hours at night. Notice the minimal changes in brown discolouration (Figure 4b).

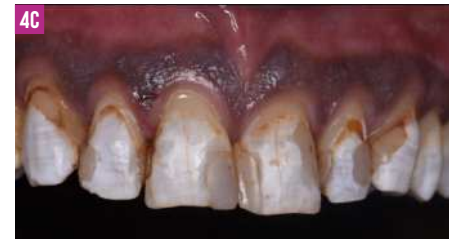
FIGURE 4C: Microabrasion with Opalustre 6.6% HCL

A fine grit diamond bur helped in removing darker stains and smoothing of enamel loss. After two weeks microabrasion with 6.6% hydrochloric acid (Opalustre), we saw a lightening of the brown stains (Figure 4c).

We then performed one cycle of microabrasion with Opalustre (6.6% hydrochloric acid). This resulted in a non-homogenous colour, and thinner enamel (Figure 4c).

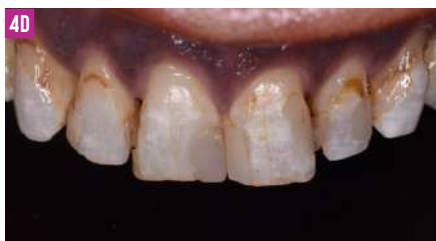
FIGURE 4D: Three-week home-based bleaching with 10% carbamide peroxide for six to eight hours at night

Vital home-based bleaching with 10% carbamide peroxide (Pola Night) was undertaken for six to eight hours a night for three weeks to remove brown discolouration, and lighten adjacent enamel to change perception of white opaque areas. This created a homogenous colour of teeth surface (Figure 4d).

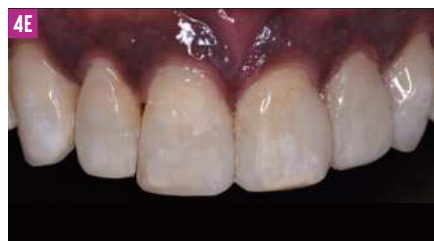
FIGURE 4E: Icon smooth surface and composite restorations

One week after Icon and composite restorations (Figure 4e), the occlusion was adjusted (especially UL3) and finished (Figure 4f).

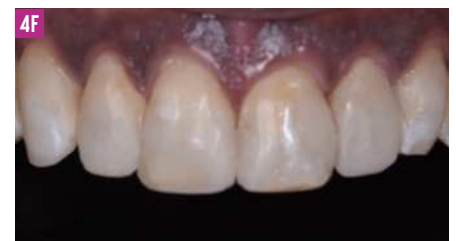
FIGURE 4F: Occlusion adjusted (especially UL3) and finishing

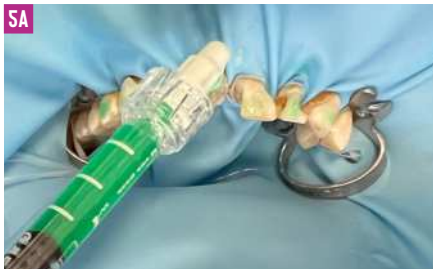
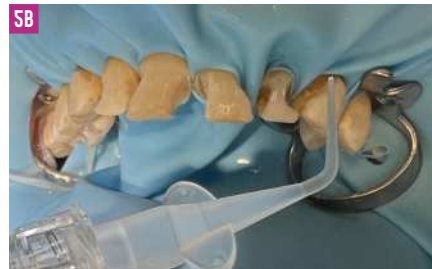
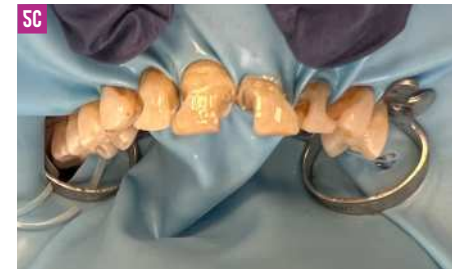
FIGURES 5A, 5B and 5C: Old composite filling removed Icon infiltration

Bonding to composite after resin infiltration does not require an additional adhesive step. If, after the infiltrant final light-curing, there is no contamination of the operatory field, composite increments may be directly applied onto the infiltrated surfaces. The depth of resin infiltration is about 60µm (Davila et al, 1975) (Figures 5a to 5c).

The old composite filling was removed with a coarse diamond bur. An LED UV torch was used to distinguish between old composite and tooth surface. Next, the following steps using Icon infiltration were undertaken:

and rinse for 30 seconds. Dentine is protected with application of glycerine (Figure 5a)

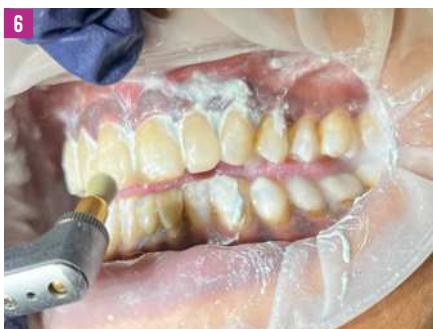
FIGURE 6: Polishing

- Icon-Dry. Let it sit for 30 seconds and thereby carry out visual inspection, dry with oil- and water-free air. If white patch disappears, do not repeat etch cycle. However, if white patch is visible then repeat etch cycle. The etch cycle can be repeated three times. The preview showed an even chromaticity (Figure 5b)
- Apply Icon-Infiltrant. Let it sit for three minutes, maintain wet lesion surface with occasional twist of syringe. Disperse with air, and floss. Light-cure for 40 seconds. Replace applicator tip. Apply Icon-Infiltrant, let it sit for one minute. Remove excess and floss. Light-cure for 40 seconds and polish. According to studies, Icon can penetrate to depth of 60 micrometre (Skucha-Nowak, 2015)
- Polish with Compoglaze (Figure 6).

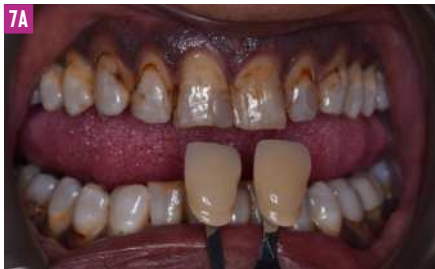
FIGURE 7A: Pre-treatment

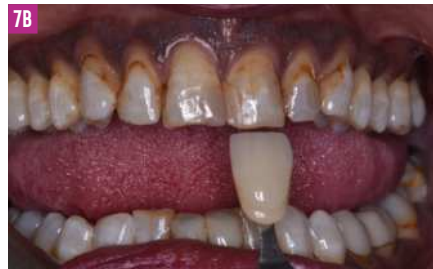
FIGURE 7B: Two-week whitening

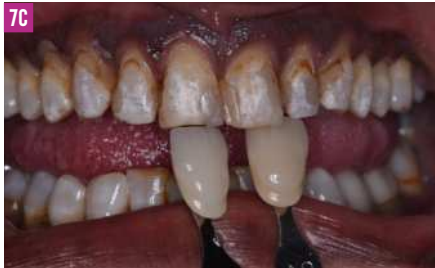
FIGURE 7C: One cycle of microabrasion

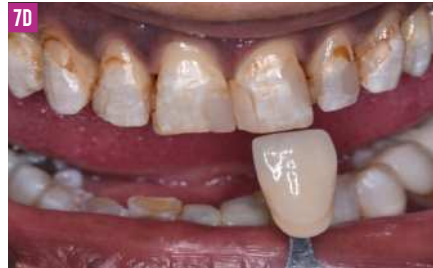
FIGURE 7D: Three-week whitening

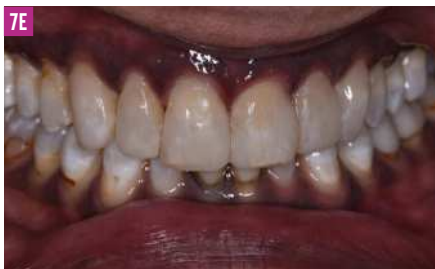
FIGURE 7E: Resin infiltration and composite resin

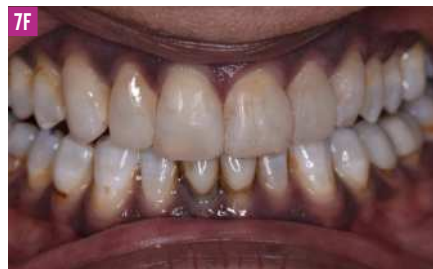
FIGURE 7F: After one-week

Overall, the patient was pleasantly surprised with the outcome (Figure 7f), reporting that the treatment has helped her to gain social confidence. As the treating clinician, I am also satisfied with the result.
